CITY OF HOLLAND (city of)
OTTAWA COUNTY, MICHIGAN

FEASIBILITY STUDY
FLOATING TIRE BREAKWATER
FOR
KOLLEN PARK

OCTOBER, 1986

PREIN & NEWHOF
ENGINEERS — SURVEYORS
ENVIRONMENTAL & SOILS LABORATORIES

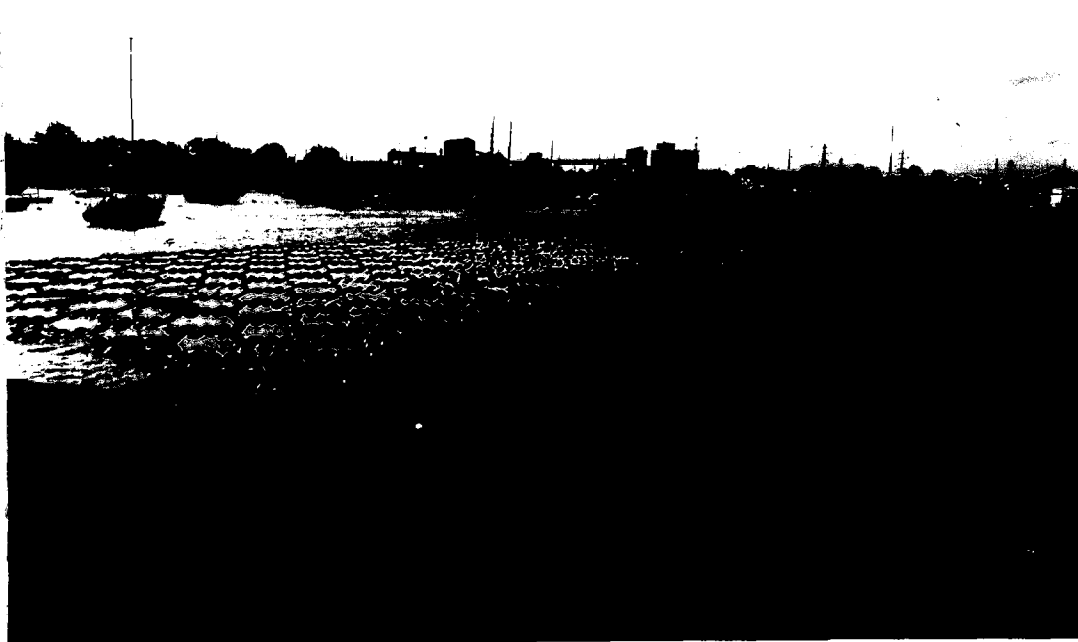
PHOTO TAKEN FROM EAST BREAKWATER LOOKING SOUTHWEST AND TOWARD SHORE - MOORING AREA ABOVE RIVER MOUTH IN BACKGROUND TO RIGHT

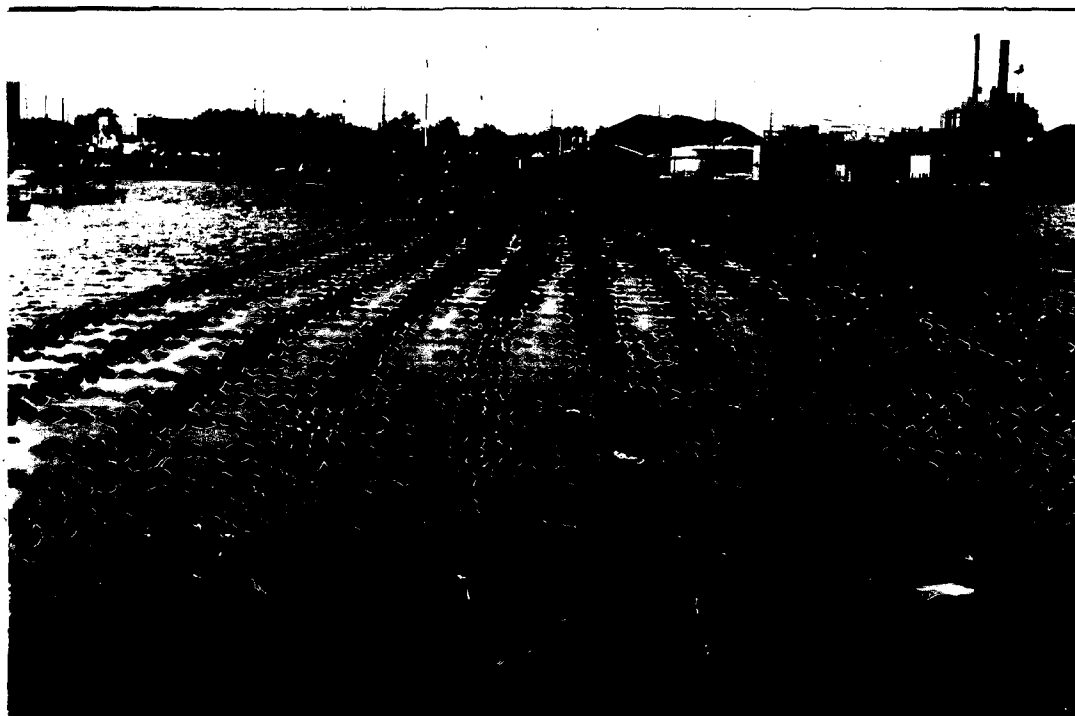
PHOTO LOOKING WEST SHOWING MODULAR CONSTRUCTION AND RELATIVE STRAIGHTNESS AND UNIFORMITY OF STRUCTURE.

The floating tire breakwater was installed with an anticipated service life of 7 to 10 years. After 5 years of service, it appears that the breakwater will survive its predicted life span.

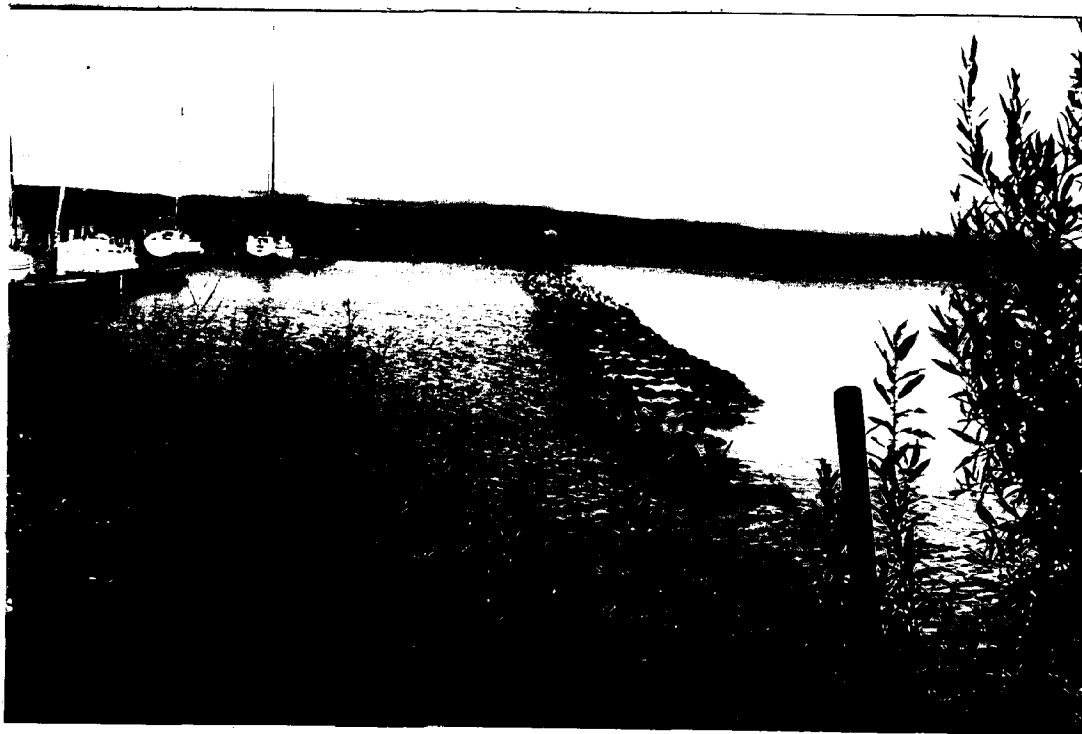
**PHOTO LOOKING NORTH SHOWING EAST BREAKWATER FOREGROUND AND
NORTHEAST BREAKWATER BEHIND.**

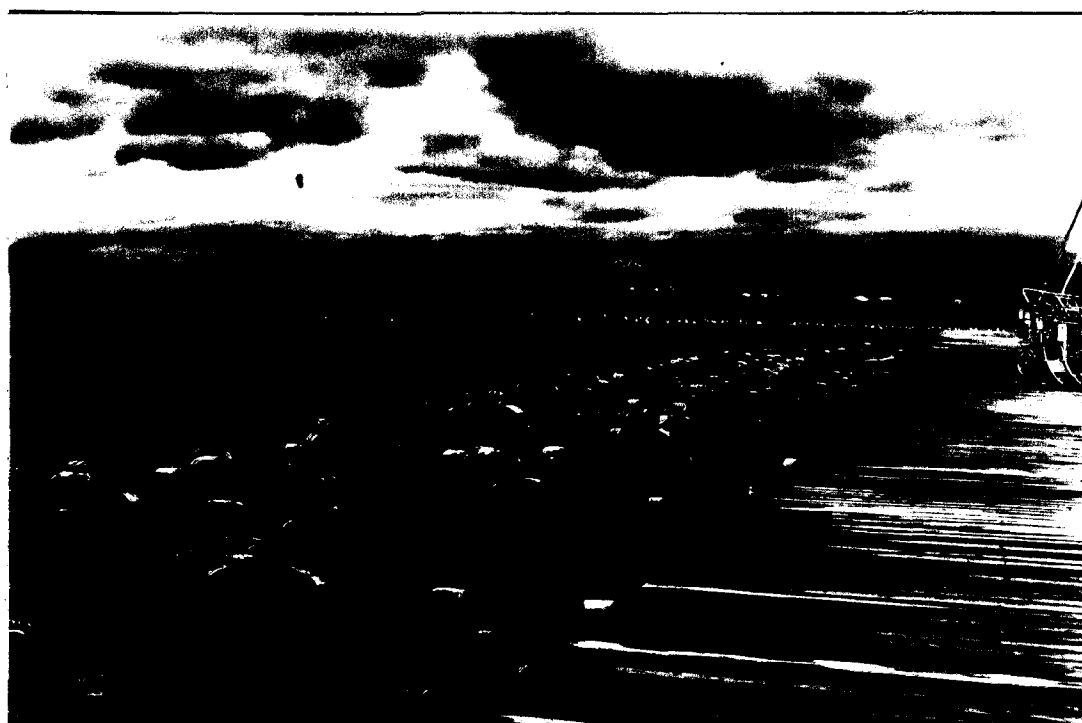
**PHOTO LOOKING EAST ALONG OUTER HEAD PIER - NOTE HOW SOME OF THE
ORIGINAL TIRES INSTALLED ALONG PIER ARE PARTIALLY SUNK DUE TO
LOSS OF FLATATION**

The breakwater is mostly constructed with truck tires. Tires are partially filled with a two-component polyurethane foam. The foam is not a closed cell foam and has gradually become saturated causing some of the tires to sink. In some time period, the amount of flotation lost will require a major rehab project.

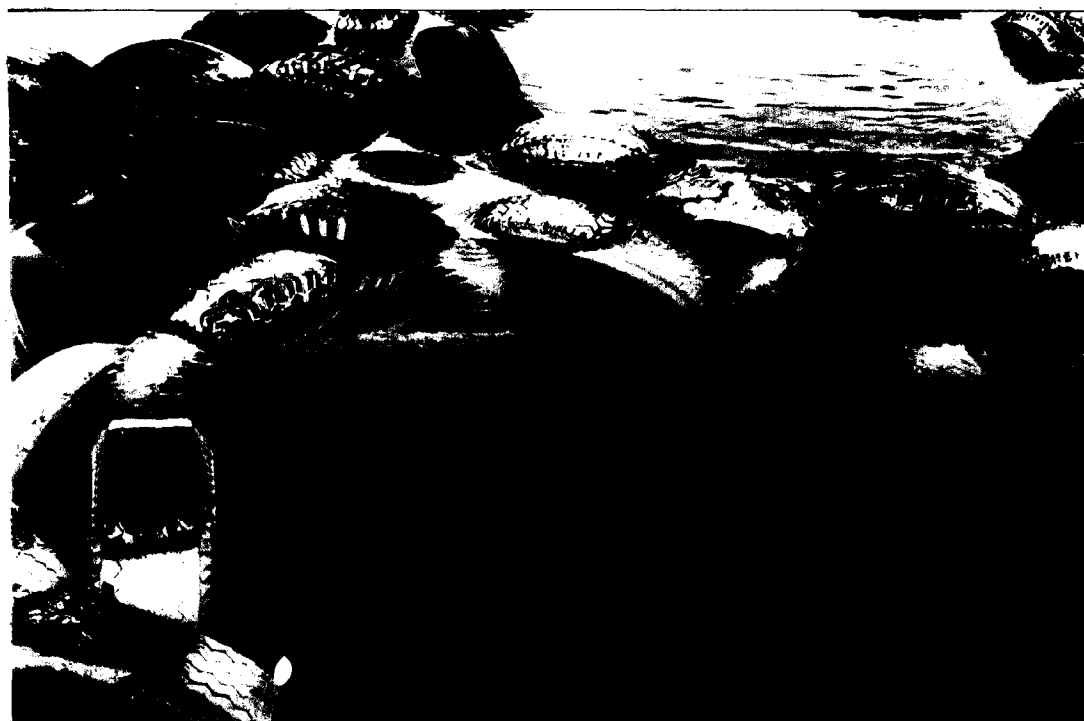
PHOTO SHOWING HEAVY BELTING USED TO CONNECT MODULES
